SOLVING TRIBO CORROSION & ASSEMBLY FAILURES

How Castrol Molub-Alloy Paste White T helped Sumitomo solve a persistent mechanical failure.

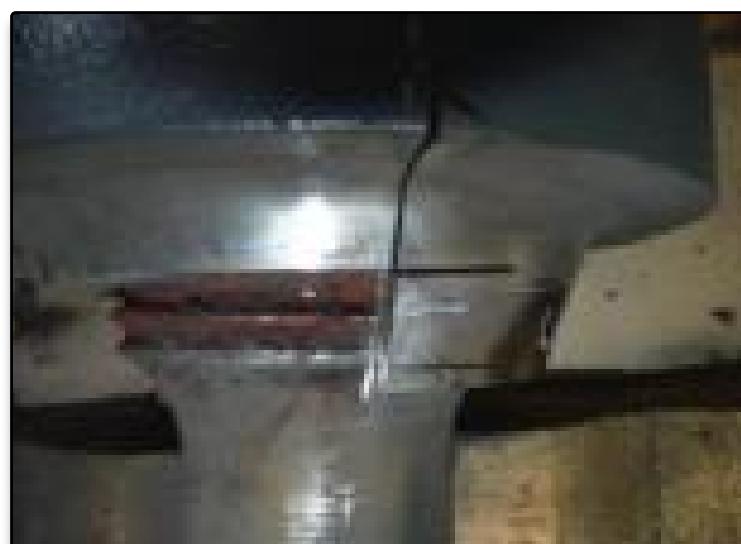
Sumitomo's injection moulding machines faced repeated failures due to:

- ✖ **Broken** holm nuts
- ✖ Seized assemblies **requiring grinding**
- ✖ **Tribo corrosion** (red-brown rust)
- ✖ Sharp edges & thread **damage**
- ✖ Use of **poor-quality** metallic lubricant paste

Pillar & nut impossible dismounting

✓ Molub-Alloy Paste White T

- **Metal-free** white paste
- **Excellent assembly**/disassembly behaviour
- Tribo corrosion & fretting **protection**
- **Reduces** edge damage during mounting

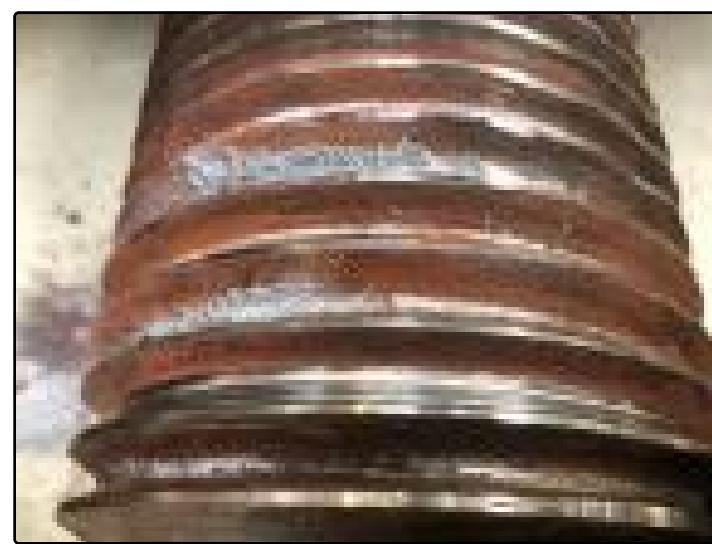
Pillar thread with tribo-corrosion
